The Use of a Lyophilized Dehydrated Complete Human Placental Membrane (dCHPM) Allograft for Wound Bed Preparation in a Trauma Induced Wound

AS DESCRIBED BY DR. MOHAMMAD SHARIF, DR. MONICA DONTAMSETTI, DR. ANILA RAFIQ | ATLANTA, GA

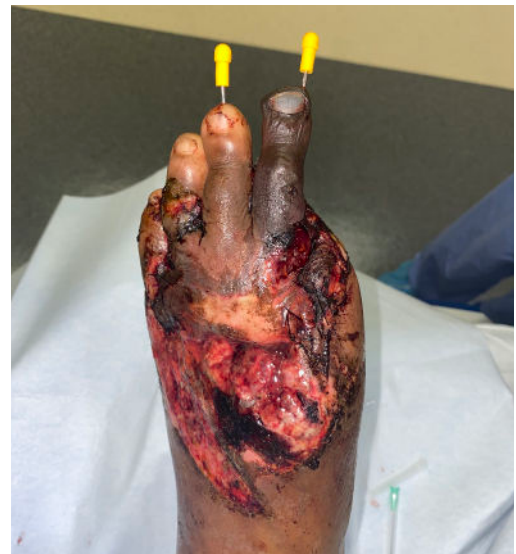
Six weeks post first ray amputation, the patient presented at the Village Podiatry facility, where he complained of pain and drainage to his foot. Upon initial examination, a large necrotic wound was noted on his dorsal foot with a cyanotic second toe. (Figure 1.)

Figure 1. Initial presentation in wound facility.

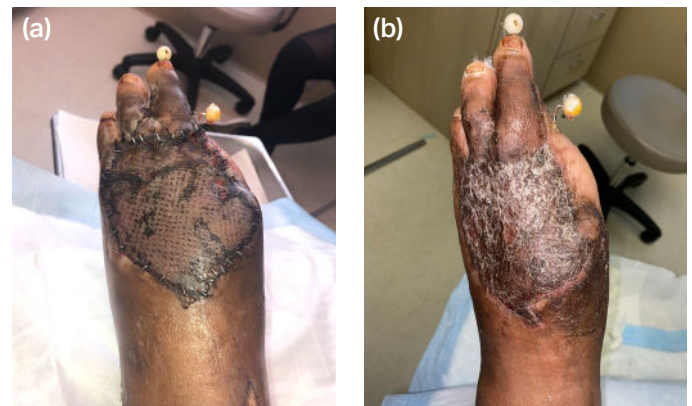
Patient had full take of the STSG and saw complete resolution of the wound within three weeks of the STSG application. (Figure 3.)

Figure 3. (a) Post STSG application. (b) At 3 week follow up with complete take of STSG.
